## Researching Prior to Building is a Smart Move

### Full Mitigation Best Practice Story

#### *Galveston County, Texas*

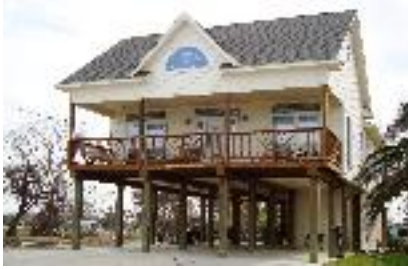
Elevated home of George and Diana Click was the only home left standing on their street following Hurricane Ike

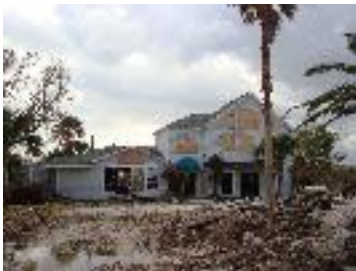
Home next door to the Clicks was left uninhabitable following Hurricane Ike
